THAMES RIVER BASIN  
SPRAGUE, CONNECTICUT  
**HANOVER RESERVOIR DAM**  
**CT 00470**

PHASE I INSPECTION REPORT  
NATIONAL DAM INSPECTION PROGRAM

AUGUST, 1980

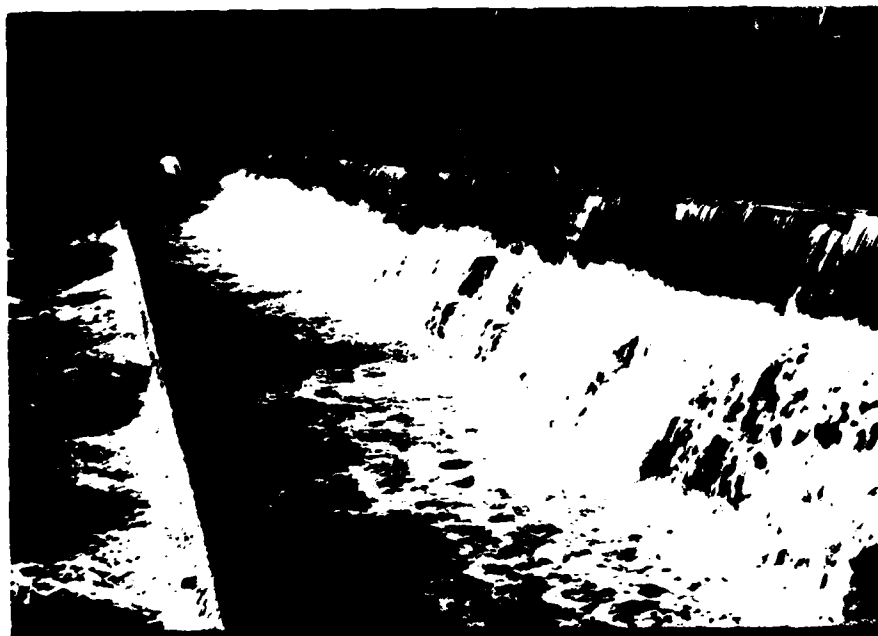
Spillway - The masonry spillway crest is in good condition. No substantial obstructions of the shallow, sand bottomed approach channel or crest were observed, though two rather large tree trunks were observed on the spillway crest (Photo 4). The concrete splash apron appears to be in good condition, with only minor cracking at the construction joints. There are overhanging trees and a small island in the broad, cobble and boulder bottomed downstream channel; however, the channel is large and these minor obstructions would not significantly lessen its effectiveness under high discharges. The masonry spillway training walls are in fair condition, with cracking and leaching of the mortar joints, particularly at the normal pool elevation.

Photo 4 - Masonry spillway and concrete splash apron (6/2/80).

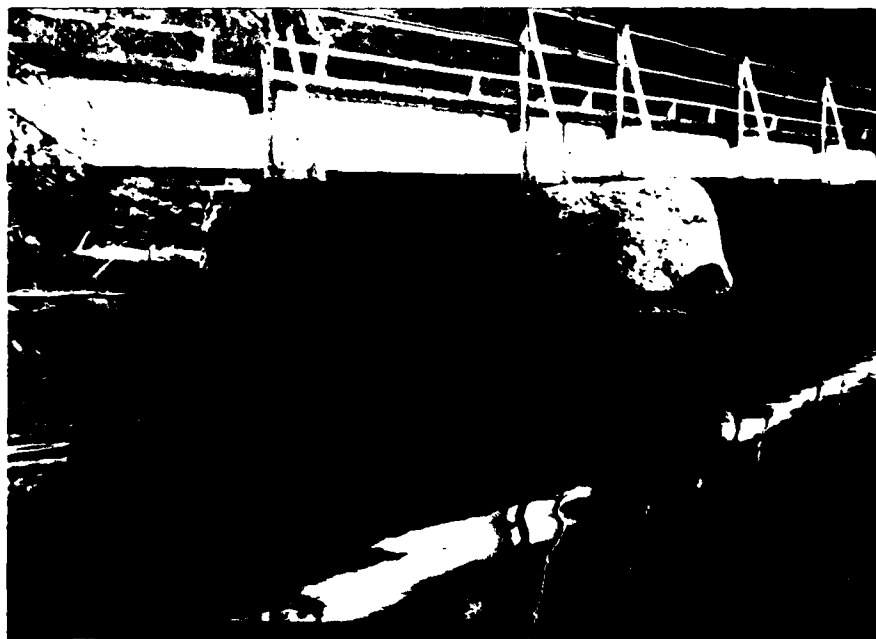
The 3 span steel bridge over the spillway approach channel is in fair condition, but the 2 concrete support piers are very badly spalled and in poor condition. The steel beams and guard rails, and the bridge deck appear to be in good condition. The spillway training walls which also serve as bridge abutments are in fair condition, as previously described.

Photo 8 - Left bridge pier. Note erosion of concrete (6/2/80).
